**EXAMPLES OF TOTARA SAPWOOD
RESISTING ATTACK BY THE COMMON
HOUSEHOLD WOOD BORER (*ANOBIUM
PUNCTATUM*)**

A Report Prepared by Paul Quinlan for Tāne's Tree Trust

31st January 2017

A report prepared on behalf of the Northland Totara Working Group.

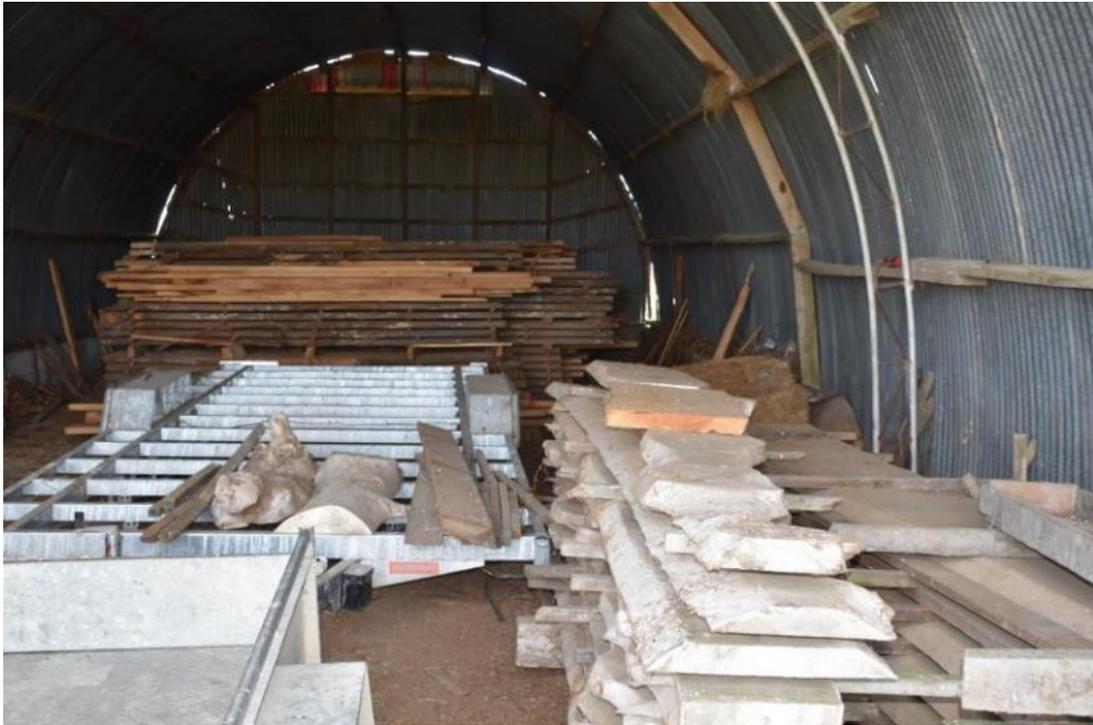
Figure: 3 – Totara slab and sawn boards stored in-fillet at the back of the shed. Slabs of kauri (grey-coloured) stored on right-hand side of the shed in foreground.

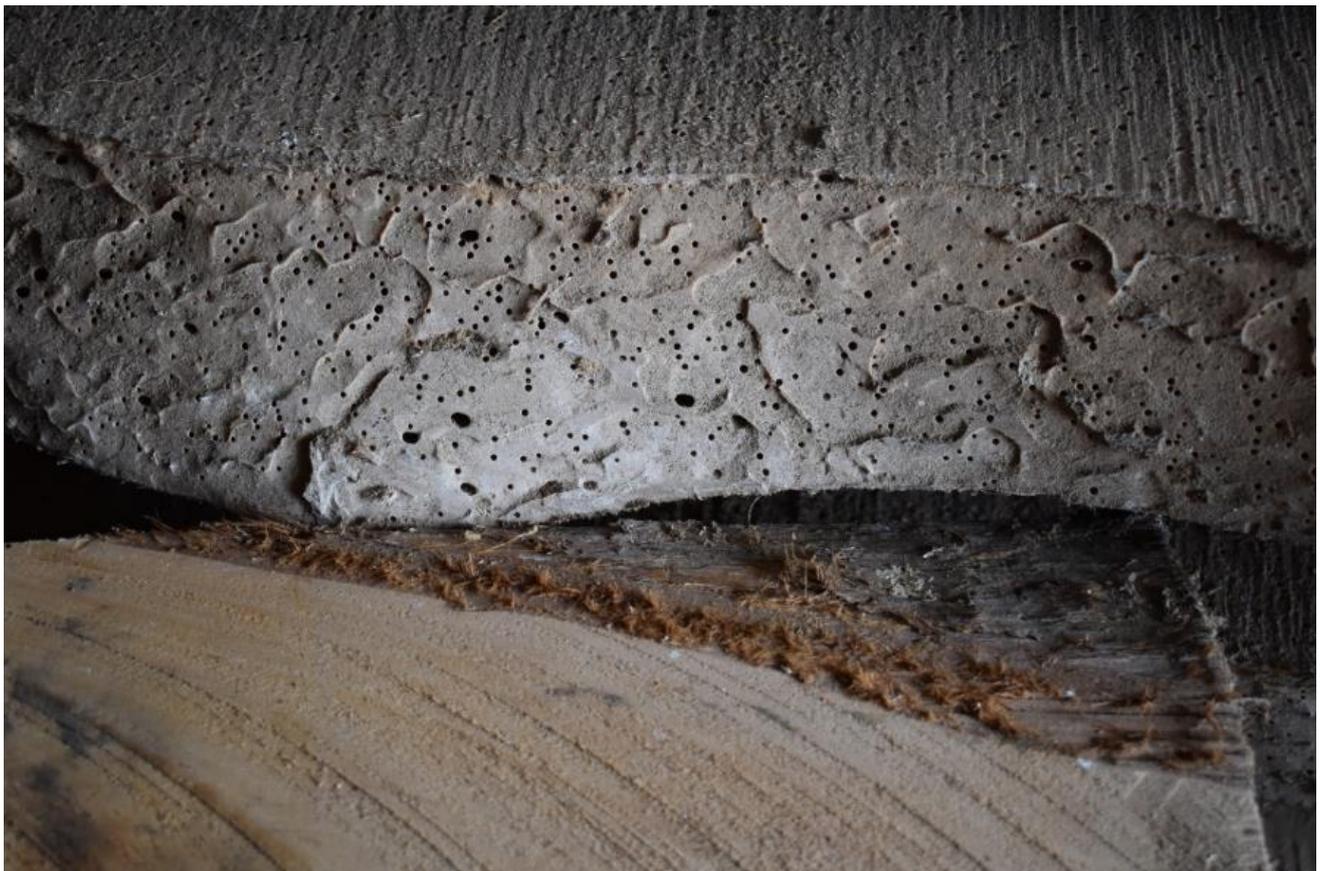
In the same shed, since 2005, slabs of a milled kauri tree (slabs up to 83cm wide), have also been stored in-fillet (i.e. 4 years longer than the tōtara timber). Although at the time no common household borer was evident on the kauri slabs, the sapwood of the kauri has since become riddled with borer. In contrast, the tōtara slabs and sawn timber - even those with the bark still on – has remained without attack, although the infested kauri slabs remain stacked less than four metres away in the same shed.

Figure: 4 – An example of kauri slab (in the top half of the photo) with sapwood riddled with the common household borer (small round holes) and the two-tooth longhorn borer (larger elliptical holes), in contrast a board of tōtara sapwood with the bark on it (in lower half of photo), without any sign of borer attack, despite being stored in close proximity to the kauri for over 7 ½ years.

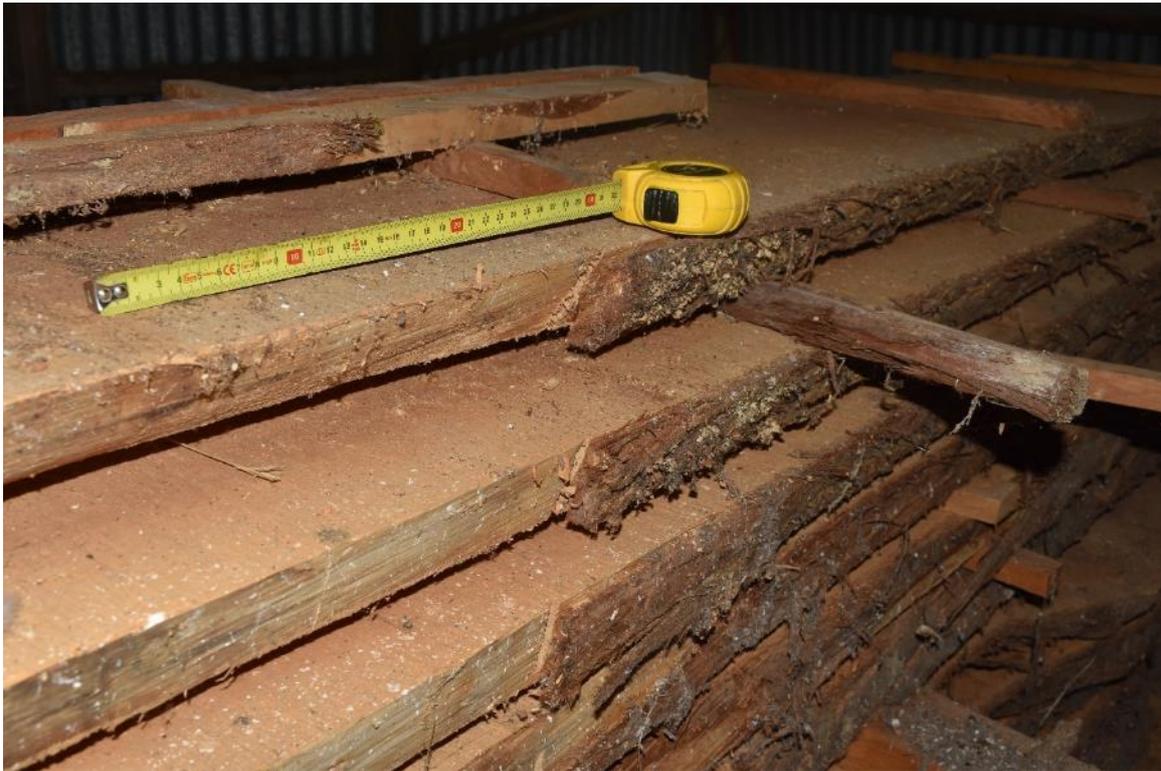
An inspection on the 18th January 2017, revealed no single observation of borer attack on any of the tōtara. This example clearly demonstrates tōtara timber, even tōtara sapwood timber, showing resistance to borer (See figures; 3- 5 below).

Figure: 5 – No evidence of borer damage was observed on any of the tōtara slabs or sawn lumber stored for over 7 ½ years in the same shed as the kauri slabs that were infested with borer.

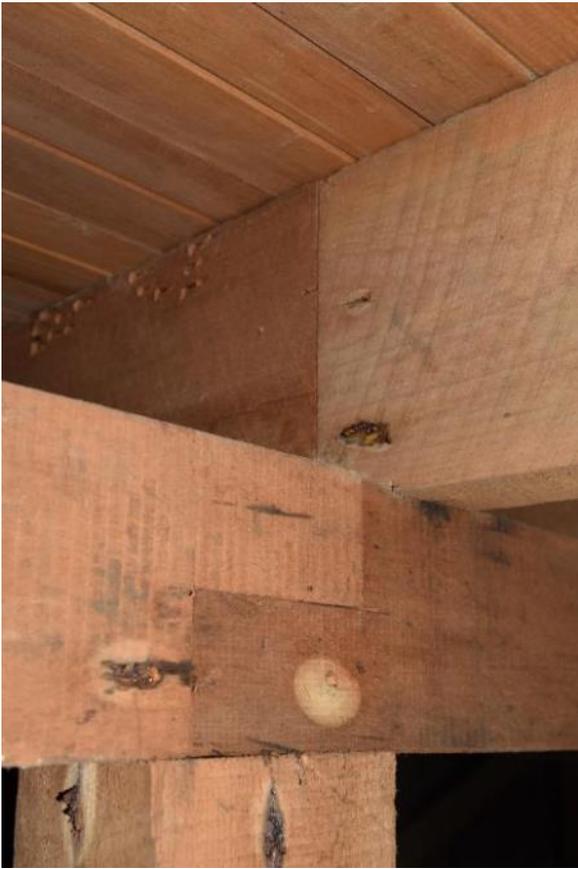
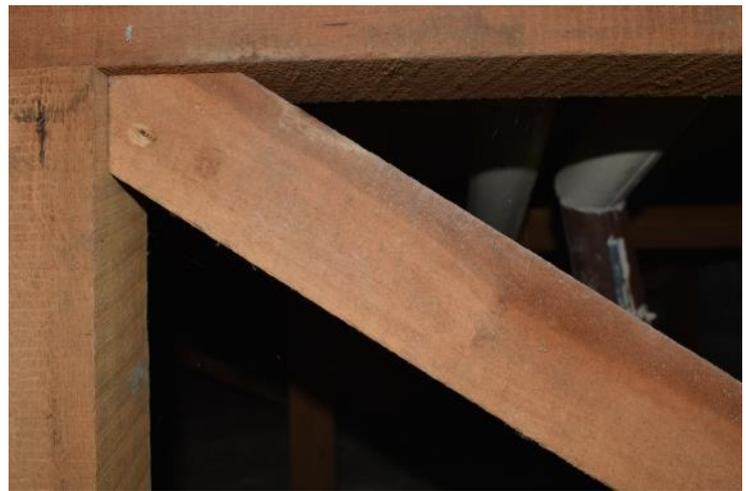
As part of this investigation, an inspection of the subfloor framing was made on the 17th January 2017. This found that although the nails and wire had mostly rusted out, the timber was in excellent condition. The only single timber defect observed was a small incidence of what is presumed to be dry-rot on an angle brace between two joists of the older house. The affected area is approximately 18cm long, 8cm wide, and 3 cm deep. It does not appear to be proportionally large enough to compromise the structural service of the timber member. No other timber defects, or incidence of borer attack, were observed in the untreated subfloor framing of either house. The untreated tōtara timber has provided excellent structural service in the subfloor framing of both houses for well over 50 years (51 & 63 years respectively).

subfloor framing also comprises a small proportion of untreated tōtara sapwood. Importantly, no evidence of borer (or other defects) was observed in these pieces of timber. Therefore, these examples demonstrate excellent structural service from untreated tōtara timber, including from some pieces that contain a portion of untreated tōtara sapwood.

Figures: 6 & 7- Untreated tōtara subfloor framing of houses built in 1953 & 1962. No evidence of borer was observed. N.B. – the distinct colour variation on the same piece of timber (– notably the angled brace in the right-hand image) presumably indicates a transition zone from heartwood to sapwood timber.

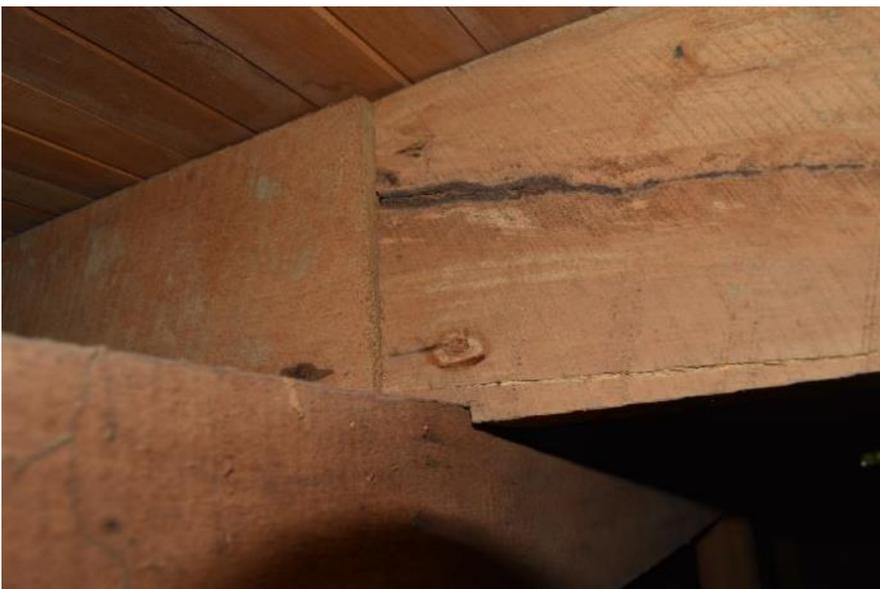
Figure: 8 – Bark encasement on one of the joists timber is presumably associated with a portion of sapwood content on this piece of timber. No evidence of borer was observed.

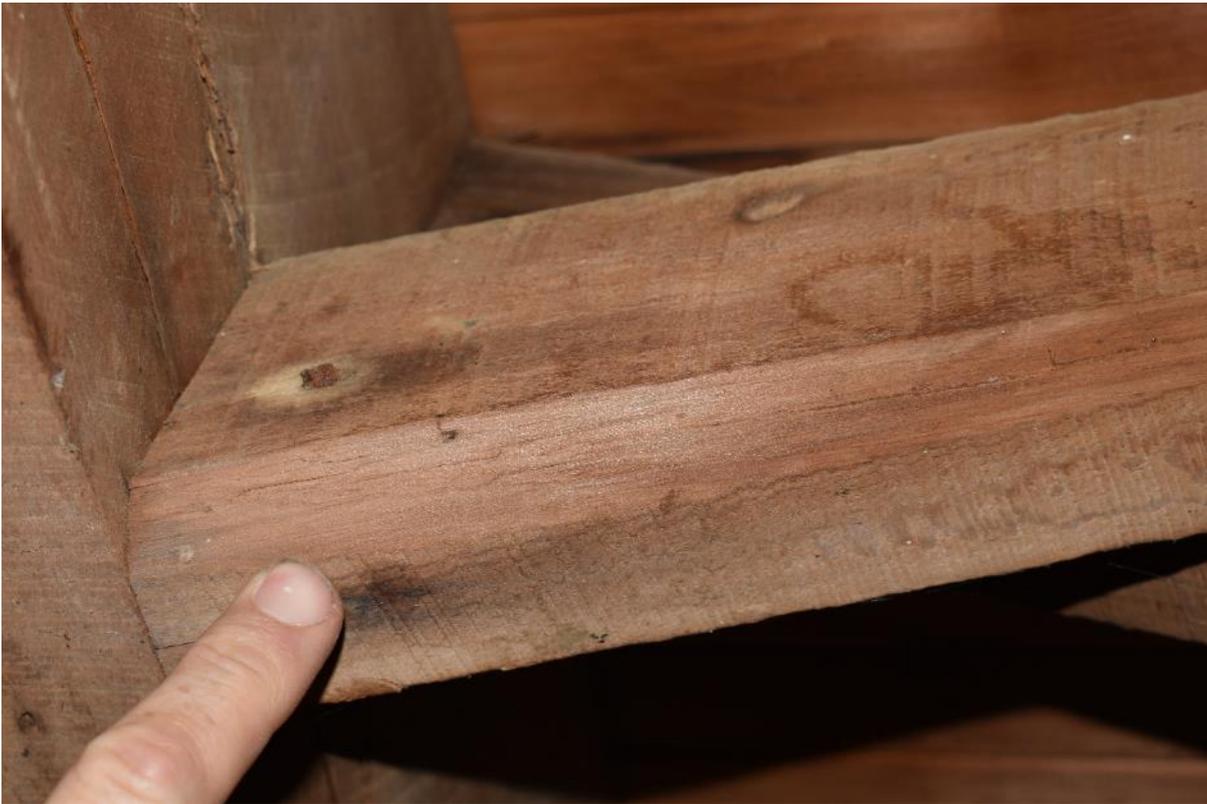
Figure: 9 – Obvious incidence of wane indicates the definite presence of sapwood on this piece of timber (in service since 1953). No evidence of borer was observed.

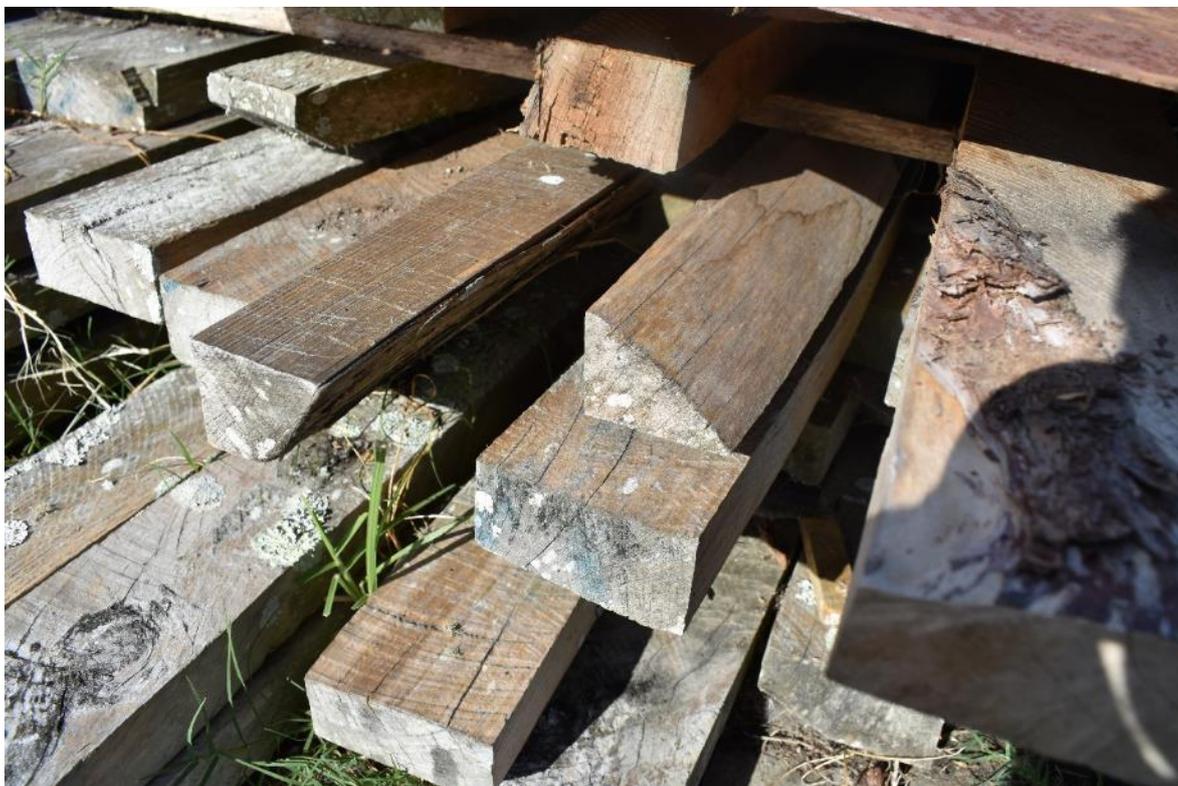
Figure: 11 – No incidence of borer was observed in the stack of untreated tōtara timber, which includes boards that clearly comprise a high proportion of sapwood timber.

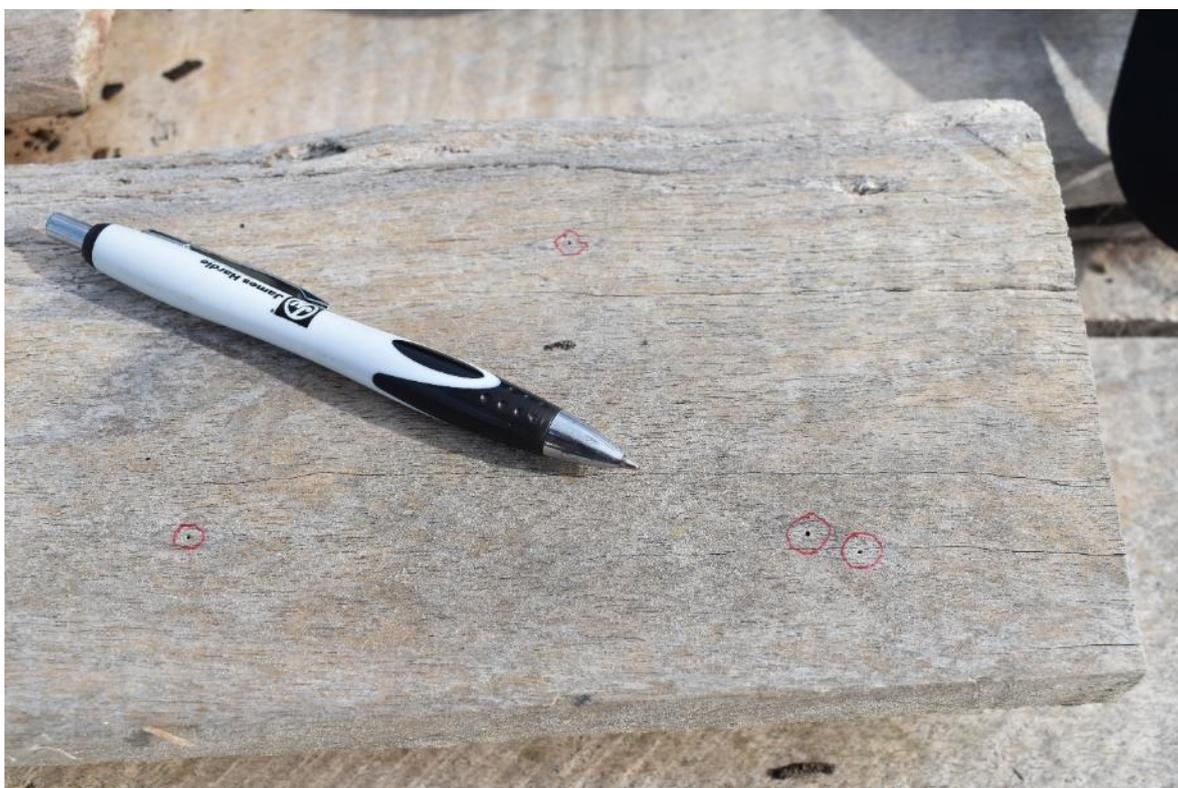
The tōtara timber has not been preservative treated. No evidence of any borer attack was observed, despite the fact that a stack of taraire timber that was milled at the same time and has been similarly stacked, less than 25 metres away, in the same paddock, shows definite signs of borer damage (See figure: 12). Even more compelling is that the taraire had been sprayed with a mixture of “Clear Metalex” (Zinc Naphthenate 60% (Zinc as metal 8%)) & thinned with mineral turpentine, but the tōtara had no such treatments applied.

Figure: 12 – In contrast to the tōtara, an adjacent stack of taraire timber, milled at the same time, has been damaged by the common household borer (*Anobium punctatum*), despite being sprayed with Clear-Metalex & Turps.

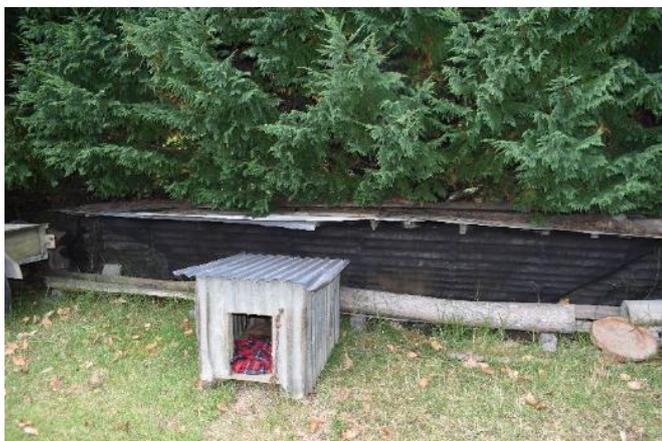
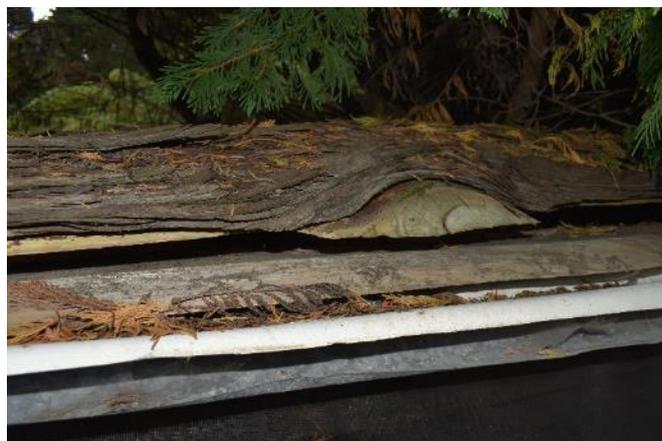
Figures: 13 & 14– Flitches from a farm-tōtara tree milled in 2008 have been used to weigh down roofing iron that covers a stack of the filleted timber stored outside under a Leyland cypress hedge for over 8 years now. No evidence of the common household borer has been observed (See figures: 15).

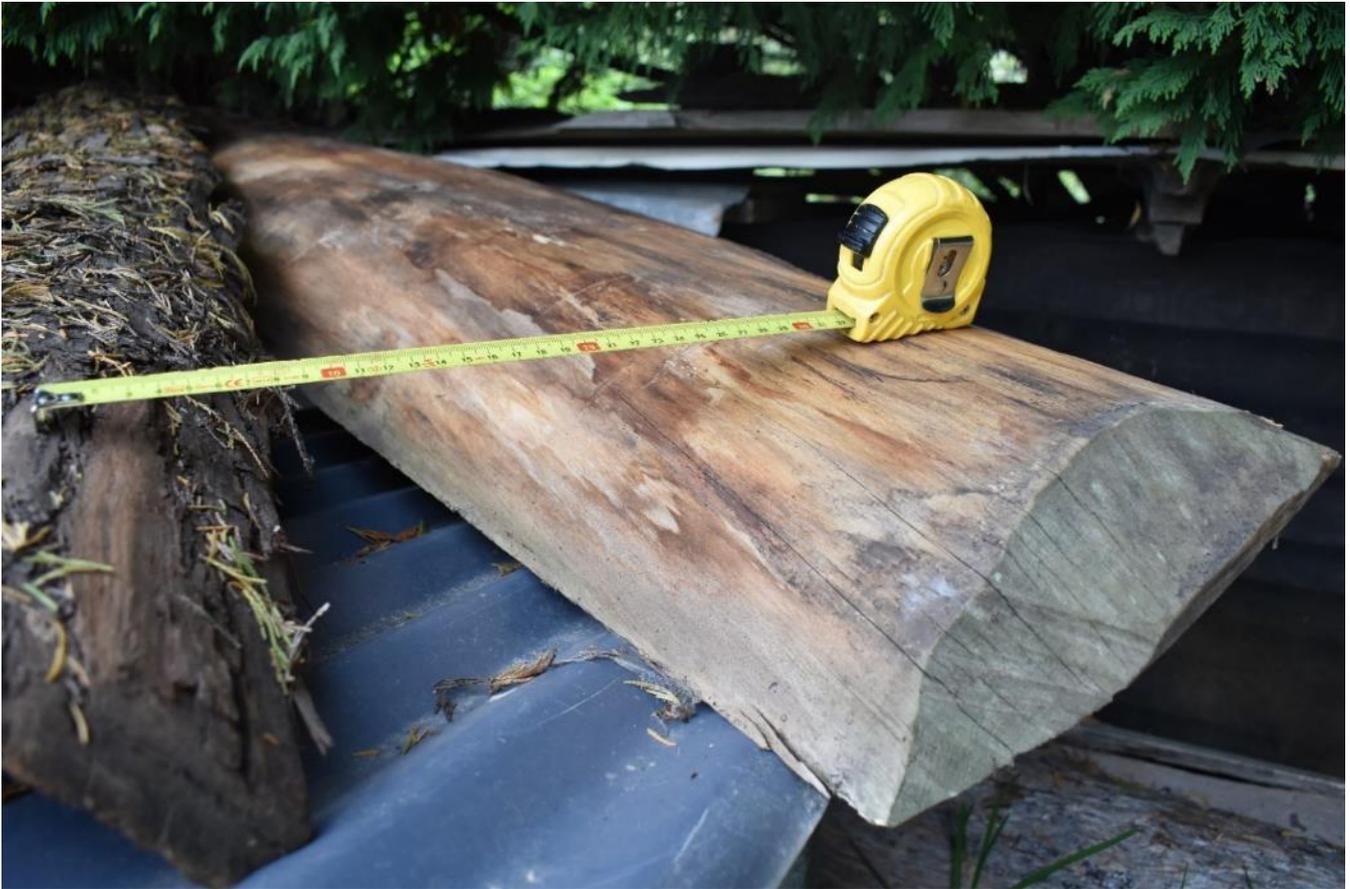
Figure: 15 – Even under the bark that had just been removed no evidence of borer damage was observed on the sapwood timber of the flitches that have been stored outside since milled in 2008 (i.e. over 8 years ago).

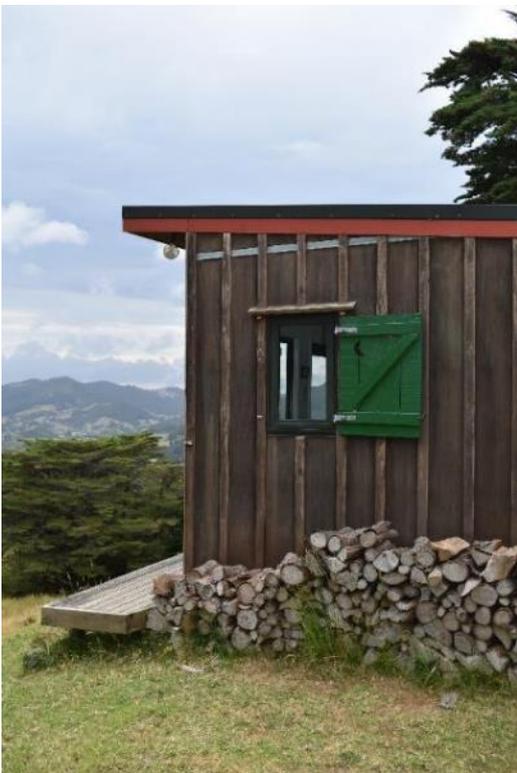
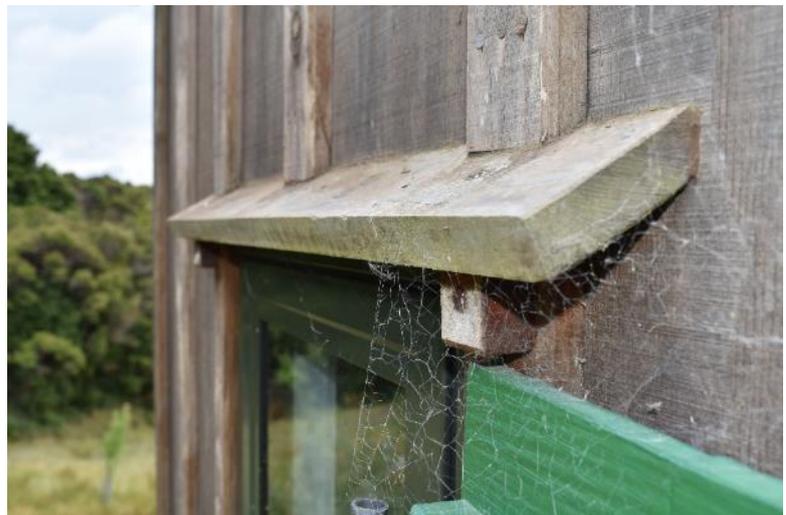
Figures: 16 & 17 – ‘Coloured’ pieces of totara timber (i.e. ones that are part sapwood/ part heartwood), were deliberately used in August 2009 as a performance trial of untreated tōtara in

exterior above ground situations. They form the weather shield hoods above the windows and door (and the support blocks). The lower drip-edges of the weather hoods comprise sapwood, the upper edges against the exterior walls are the darker heartwood. The colour transition is faintly visible on the end-grain in the above photograph. The interface with the wall was filled with clear silicone sealer and the timber painted liberally with two coats of a timber preservative oil (Red ENZ, Natural Timber Finish and Preservative). The three weather hoods are still in good condition now after more than 7 years' service without any maintenance or recoating.

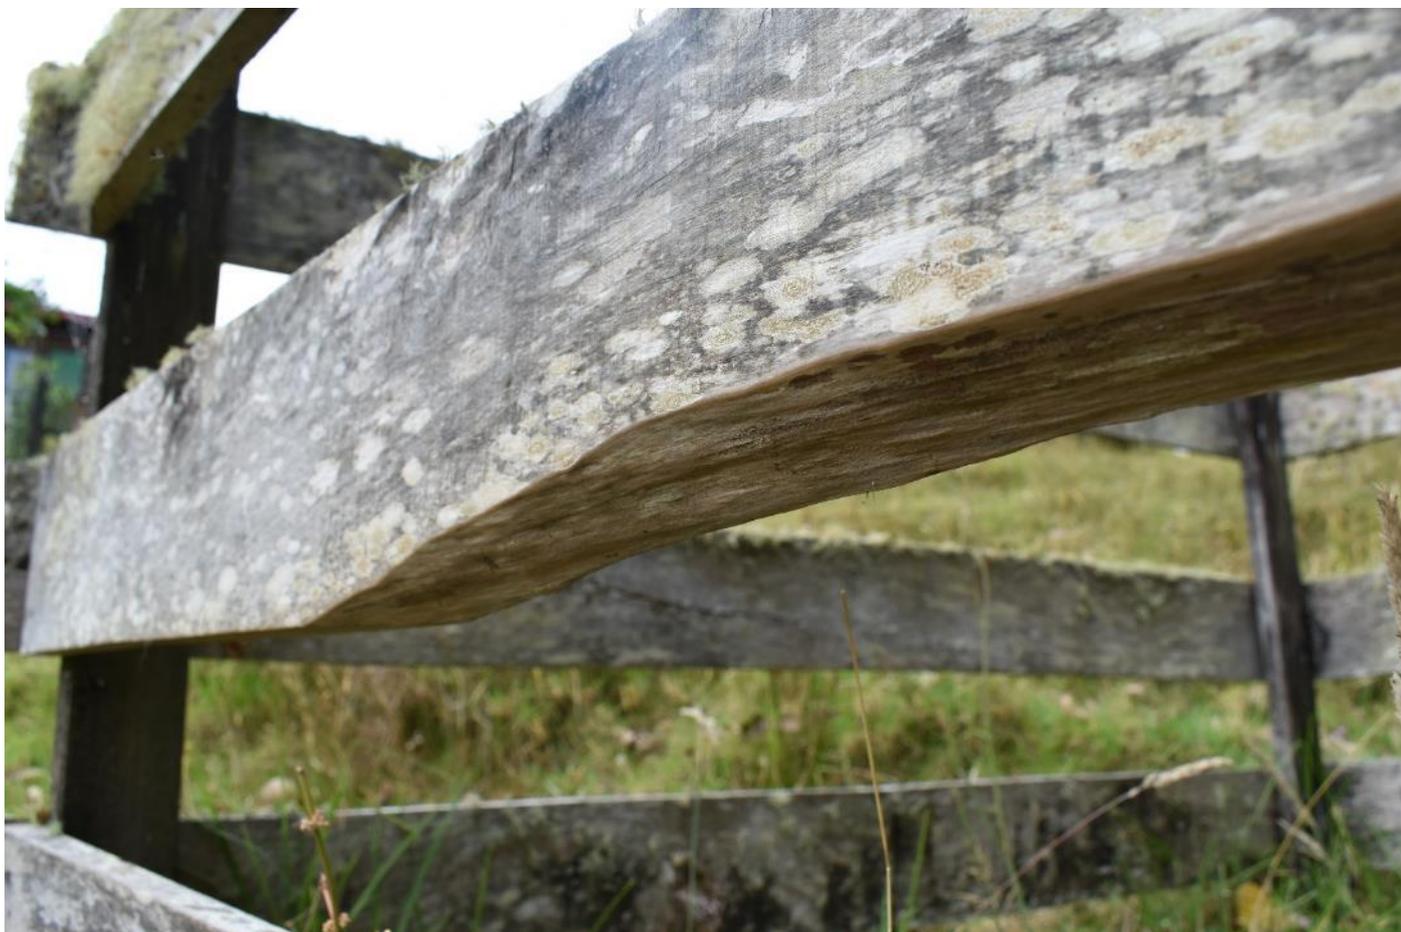
Figure: 18 – Untreated tōtara timber rails milled in 2008 and used in service outside since 2009 (i.e. 7 years so far). N.B. - many boards have wane and will therefore include a portion of sapwood. Although not expected to be durable in this exposed exterior application, no evidence of borer or rot/deterioration is yet evident.

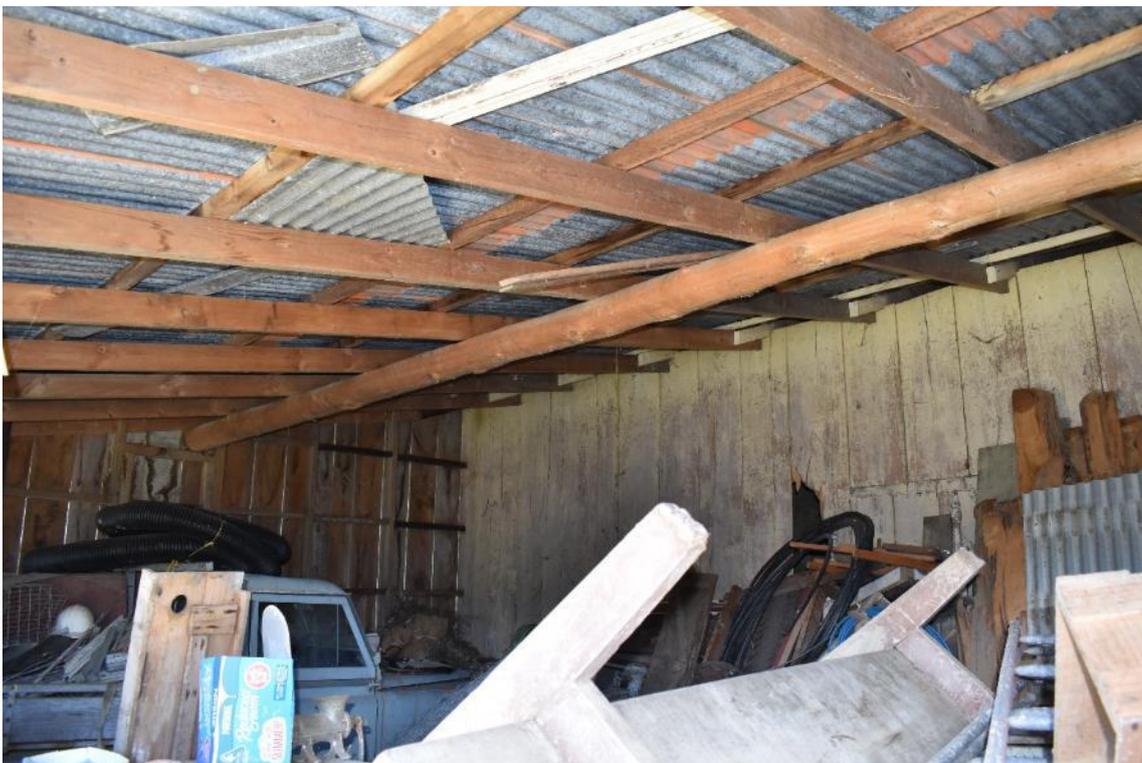
The tōtara trees were cut and used green. John cut the branches flush with an axe and the bark and was removed. The beams have been partly square-sided with the skilful use of an axe (John think's Bill Bramley did that), but for much of the length the natural round of the tree's wood immediately under the bark remains. This natural round surface, and just under, is certainly sapwood. One beam forms the lintel above the doors and the other supports the roof rafters under the mid-point of their spans. The tōtara beams are 8.57metres long and span at least 8.37m. The lintel has other boards fixed to it therefore its diameter could not be accurately measured although the natural round surfaces indicate that it was clearly a relatively small diameter tree. In contrast, the tōtara support beam located under the mid-span of the rafters, is fully exposed and could be more accurately measured, although the rough 'squaring' of two faces of the last 2metres near the larger end, means that the large end diameter could only be estimated (at 30cm), based on the remaining half to two-thirds of the natural round of the tree. The small end diameter was accurately measured at 160mm.

Figure: 21 The 8.57m long beam (under the rafters) has provided the mid-span rafter support since Oct. 1968, is an untreated tōtara pole, mostly still in the round form, but partly flat-sided (by axe) on top and near the butt end. The small end diameter is 160mm and the large end diameter is estimated at <30cm. The beam had the bark removed and was used green. Although borer is present in other timbers in the shed, no borer attack was observed at all in this (or the other) tōtara beam.

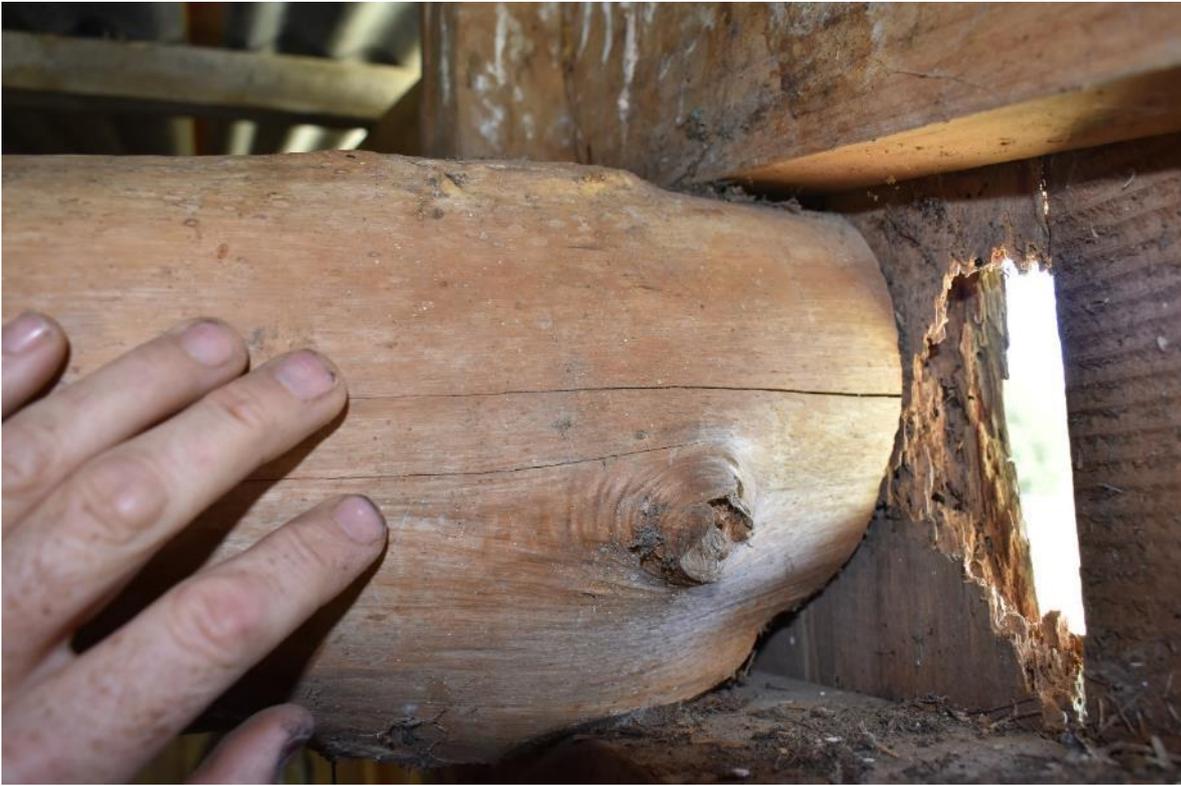
Figure: 21 – The small end of the beam has a diameter of 160mm and immediately abuts a rotting board of the exterior cladding. No borer or rot is evident in any part of the untreated tōtara beam. It has been in services for over 48 years.

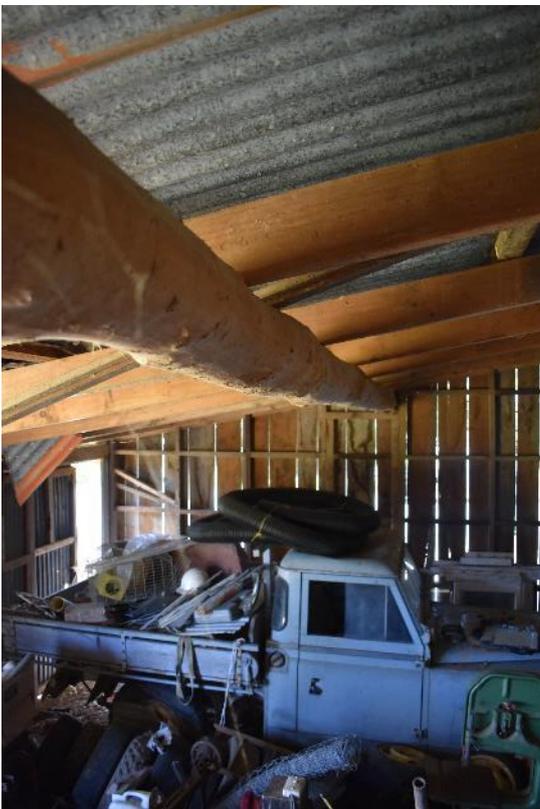
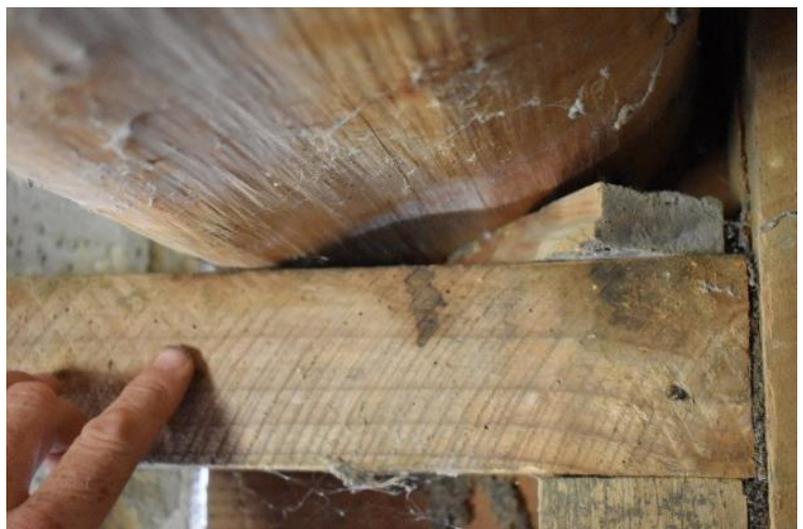
The rest of the shed addition is made from various timbers that appear to be mostly kauri. Amongst the items stored in the shed, are some kauri slabs. Robert Hayes says the sapwood of the kauri has some borer damage. House borer holes were also observed in the nogs of the framing (thought to be kauri sapwood), directly on top of which the large end of the mid rafter tōtara beam rests (See figure: 23).

Figures: 22 & 23 – View to the large (butt) end of the 8.57m long tōtara beam, which rests on a piece of framing timber with house borer exit holes. However, no borer or rot is evident in any part of the untreated tōtara beam (N.B. the smooth natural round surface of the timber under the bark).
